Comparison of metallurgical and corrosion test results obtained on three materials treated by the Nitreg®-ONC process.

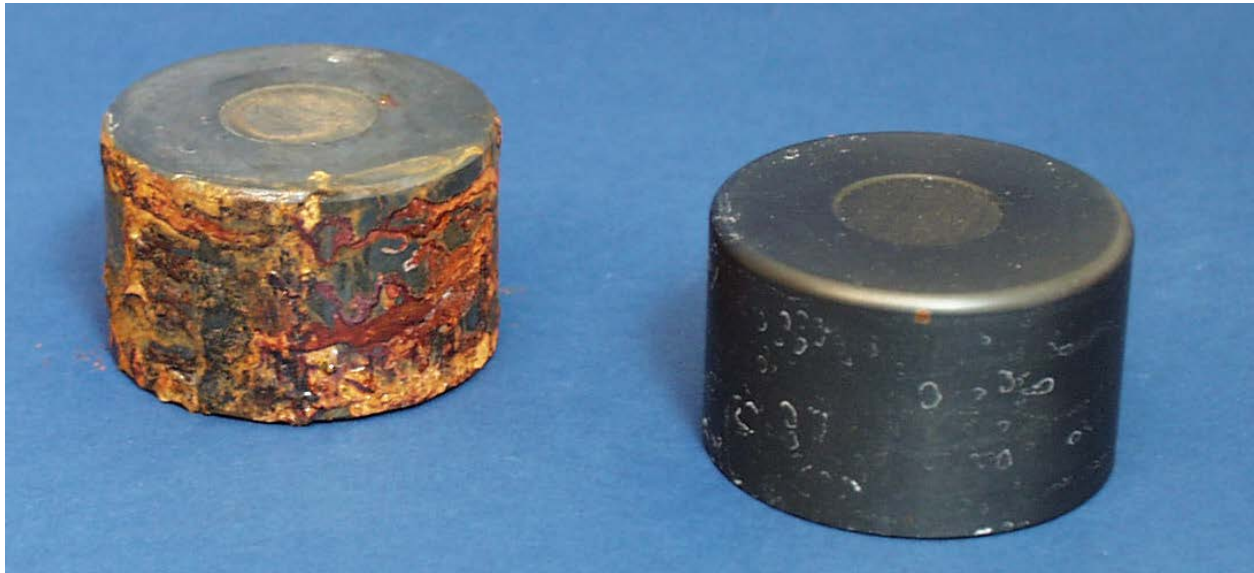
Corrosion resistance compared on a brake piston

The brake piston on the right treated with Nitreg®-ONC showed its 1st corrosion spot after 400 hours in a salt spray test. The brake piston on the left treated with a competitive technology had 60% of its surface corroded after 400 hours.
